# The REMR Bulletin

Volume 9, Number 1

March 1992

# Spillway Remediation at Saylorville Lake

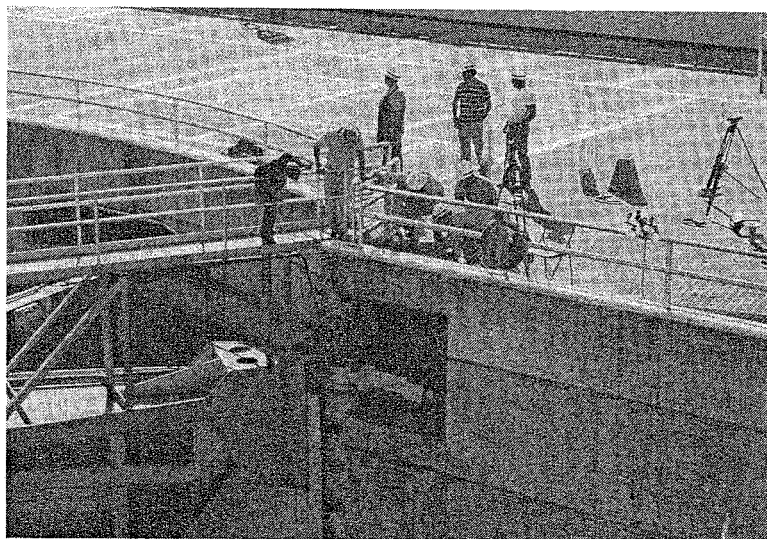
Figure 1. Inspection being made at site during training session.

The concept of objective condition assessment is central to the REMR Management Systems. Standard field inspection procedures (Figure 1) yield data that in turn produce a Condition Index (CI), a numerical rating that ranges from 0 to 100 and is de-

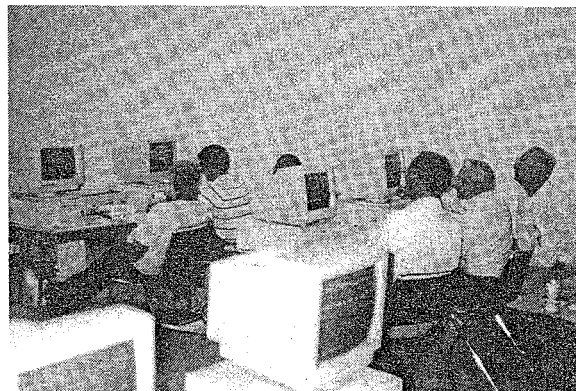
**Figure 3. Training participants entering CI inspection data into REMR Management System software.**

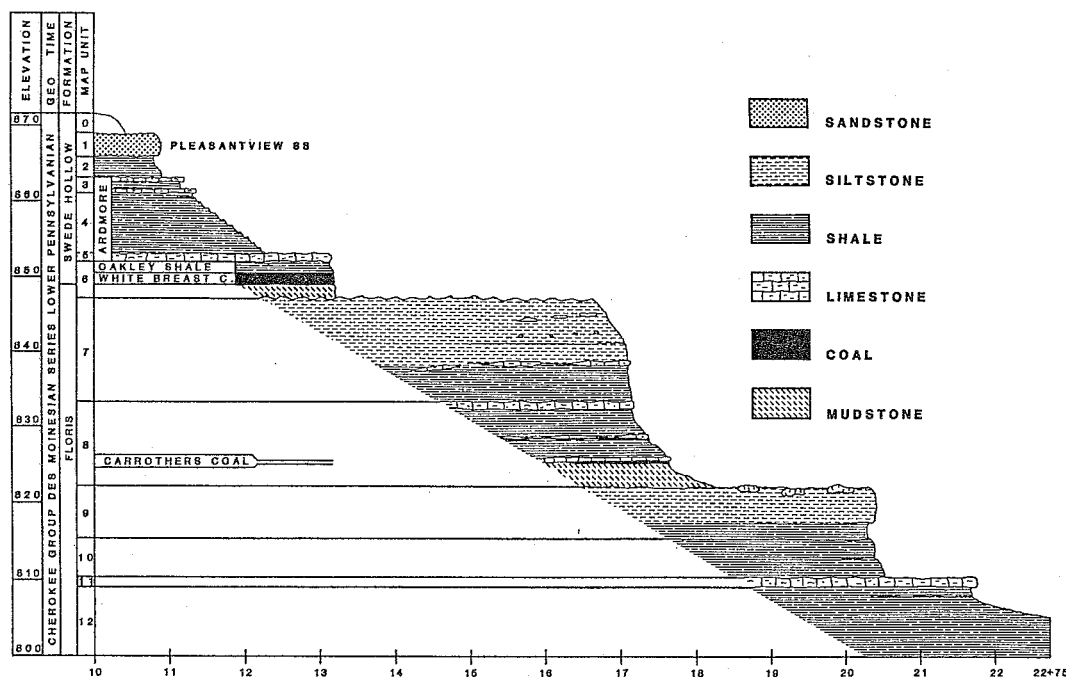
The bluffs flanking the Des Moines River valley have a foundation of Pennsylvanian age rocks capped by Quaternary age deposits of glacial till, alluvium, and loess. The bedrock consists of a repetitive layer-cake of sandstones, siltstones, shales, limestones, coals, and mudstones (Figure 1). The sandstone and limestones are rela-

tively dense and erosion resistant. Fresh exposures of the siltstones and shales are also resistant; however, if subjected to repeated wetting and drying and freezing and thawing, they weather rapidly. A unit of siltstone/sandstone forms the channel floor, and a relatively flat grade of siltstone/sandstone exists for approximately 900 ft from the end of the paved concrete apron. During construction, a soil cap approximately 4 ft thick was placed over the siltstone and sandstone to protect the spillway from cycles of freezing and thawing.

Figure 1. Saylorville Spillway geologic profile along centerline.

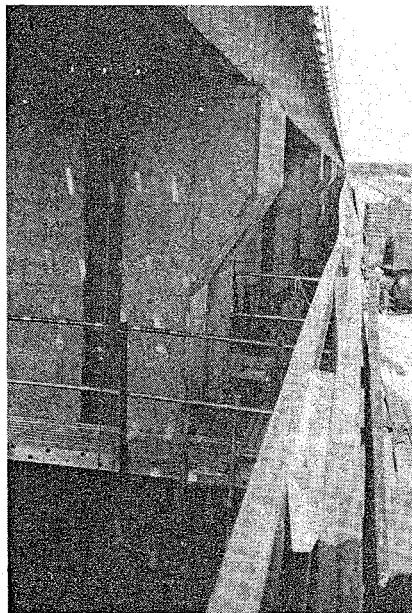
**Figure 6. Contractor's scaffolding arrangement prior to the removal of the dam's service bridge.**

After analysis of the data and evaluation of the effectiveness of the epoxy injection program, the District decided to abandon the epoxy injection method and opted to modify the contract to remove and replace the remaining badly cracked and deteriorated pier stems. Seven pier stems (31, 32, and 38 through 42) were removed and replaced. The contractor's proposal to do this work was \$366,990 (\$52,427 per pier stem). Since all work had already been accomplished on the other piers and the contractor had already replaced the service bridge (Figure 6), no additional work was required for these piers. They will be periodically inspected to evaluate the effectiveness of the injection process.
